# **Leisure Unlimited, Inc.**

***Vinyl Liner Replacement Specialists***

# Measuring The Pool

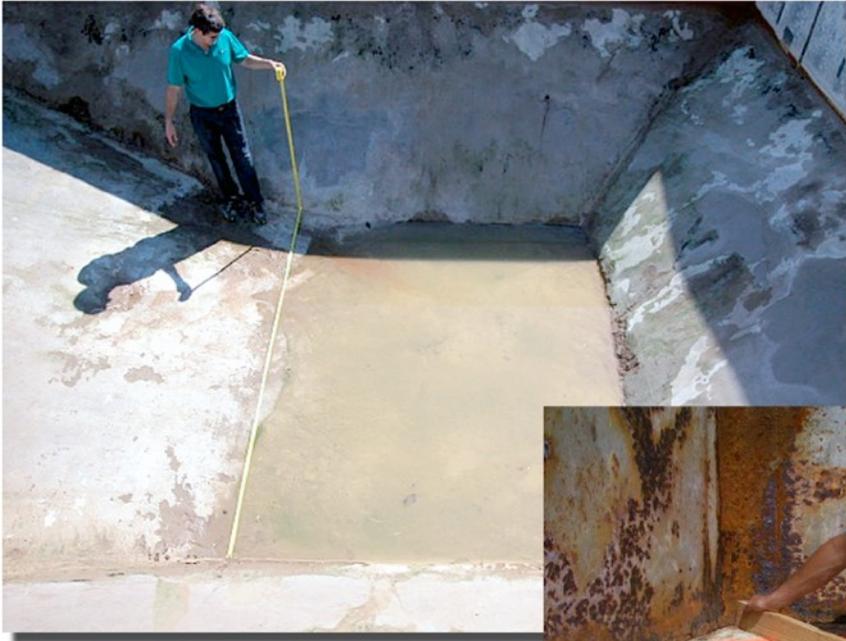
Your pool should be measured after it is empty and the old liner is removed. This allows accurate measurements to within 1/2 of an inch on all dimensions. Other potential problems with liner fit can also be easily seen and accommodated for -- before the liner is ordered.

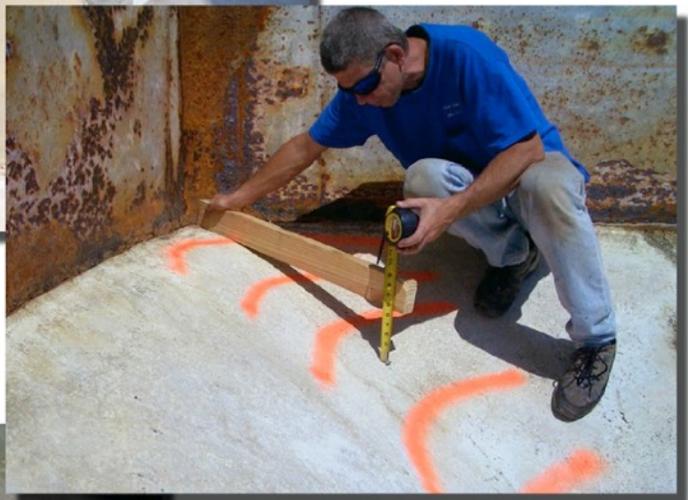
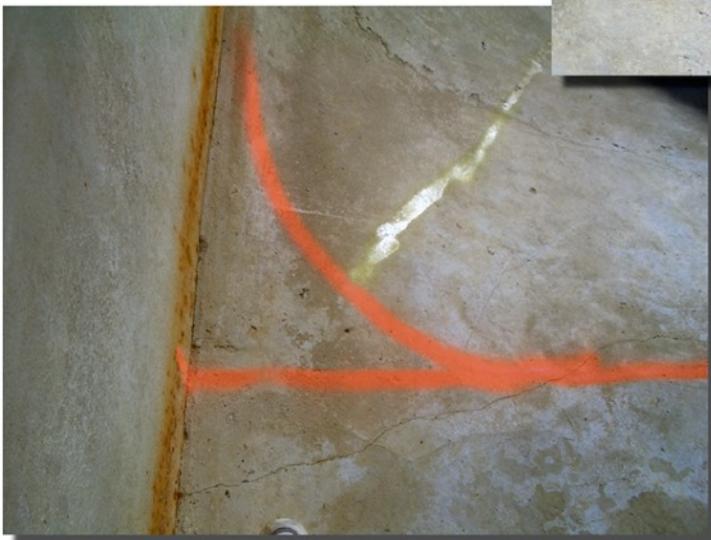
Photos, such as these, are sent to the factory; enabling them to make a better fitting liner.

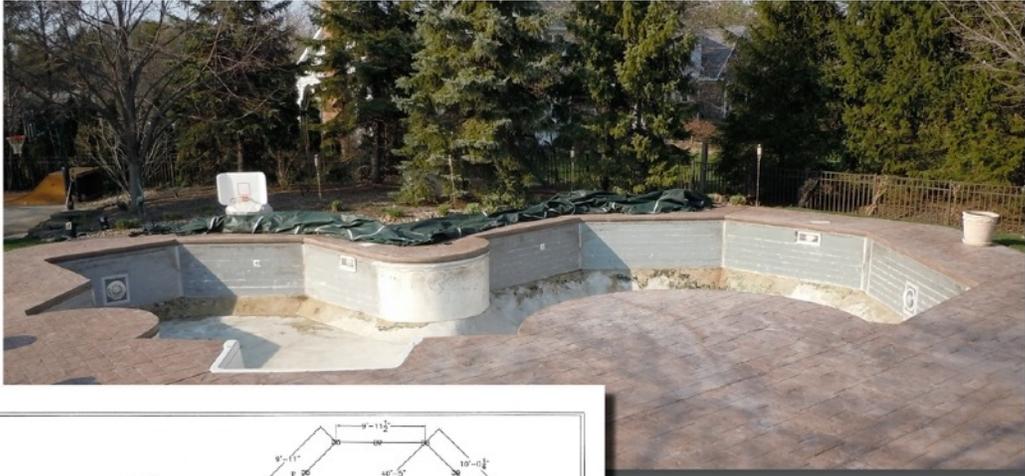
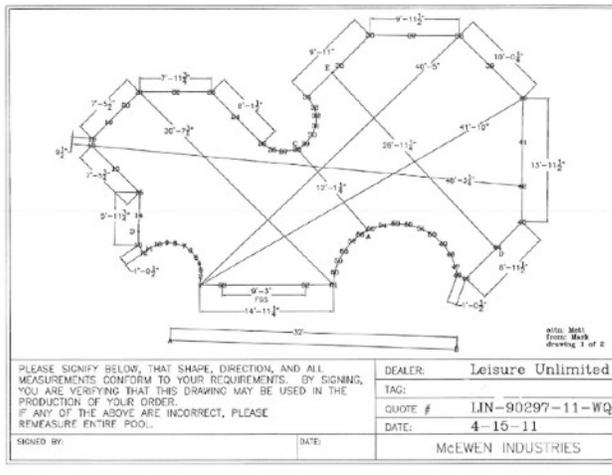
We have the expertise and experience that is necessary to measure and fit complex pool shapes that may contain difficult to measure features such as interior steps or multiple level bottoms.

This pool was measured to the 1/4" at 63 perimeter points, 6 cross and diagonal measurements, and at least a dozen more bottom points depicted in a second blue print.

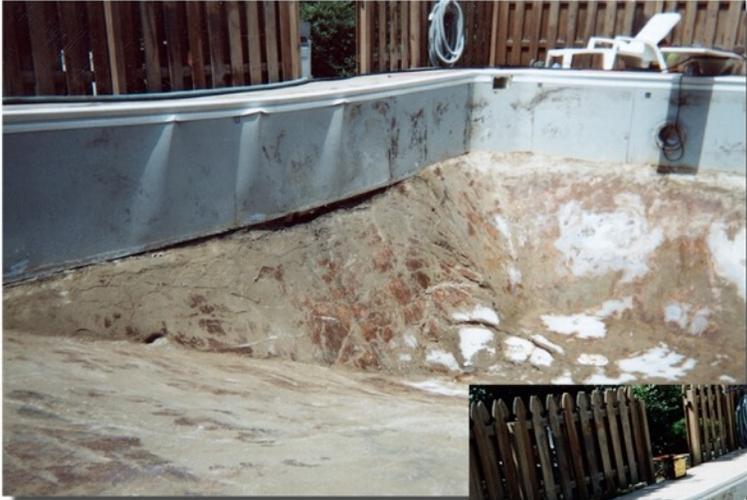
Before

This bottom has ground water damage but is fully repairable. All loose pieces and soft areas will be removed and a cement/vermiculite pool bottom mix will be troweled into place.

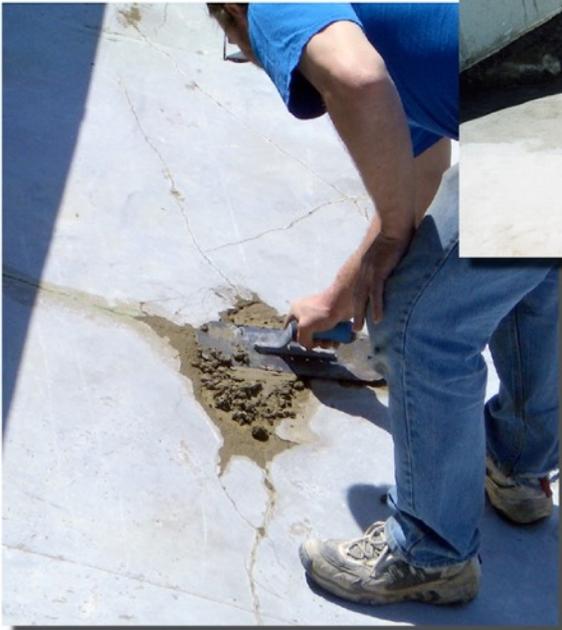
This pool's bottom was extremely thin in some areas, and required spot patching with sand and cement.

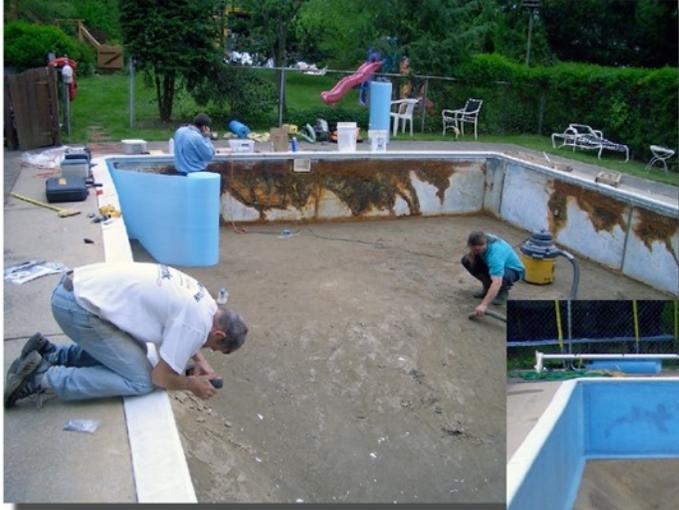
This sand bottom was carefully cleaned by hand, and then trowled smooth just before the liner was fitted.

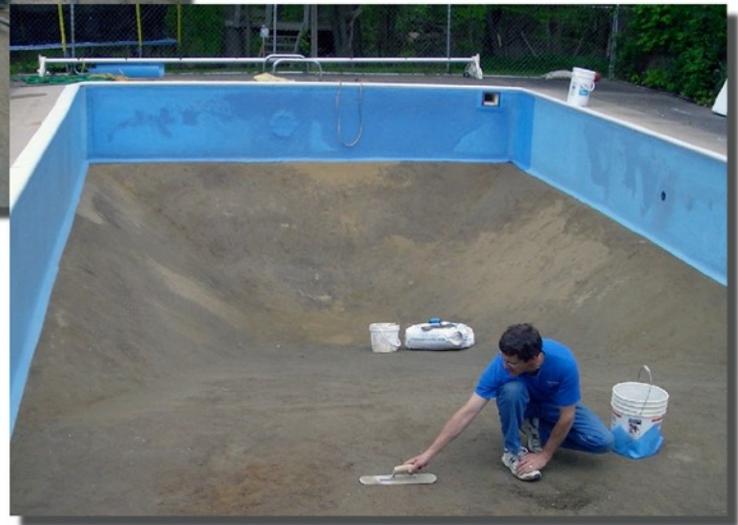
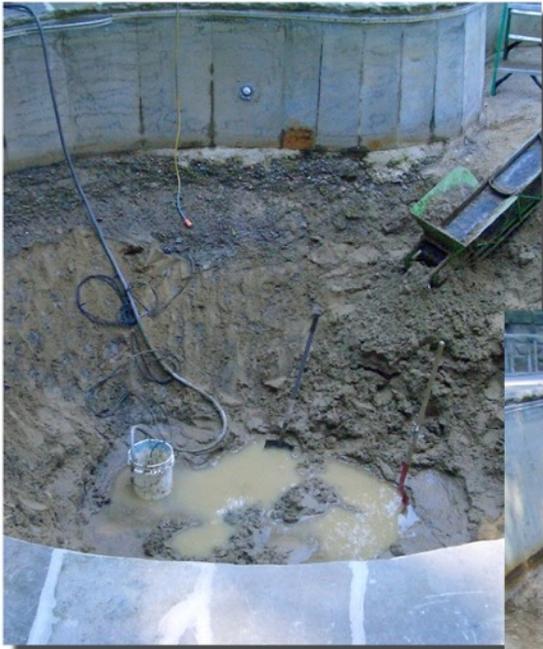
This pool's bottom was reshaped, and a new hard bottom installed.

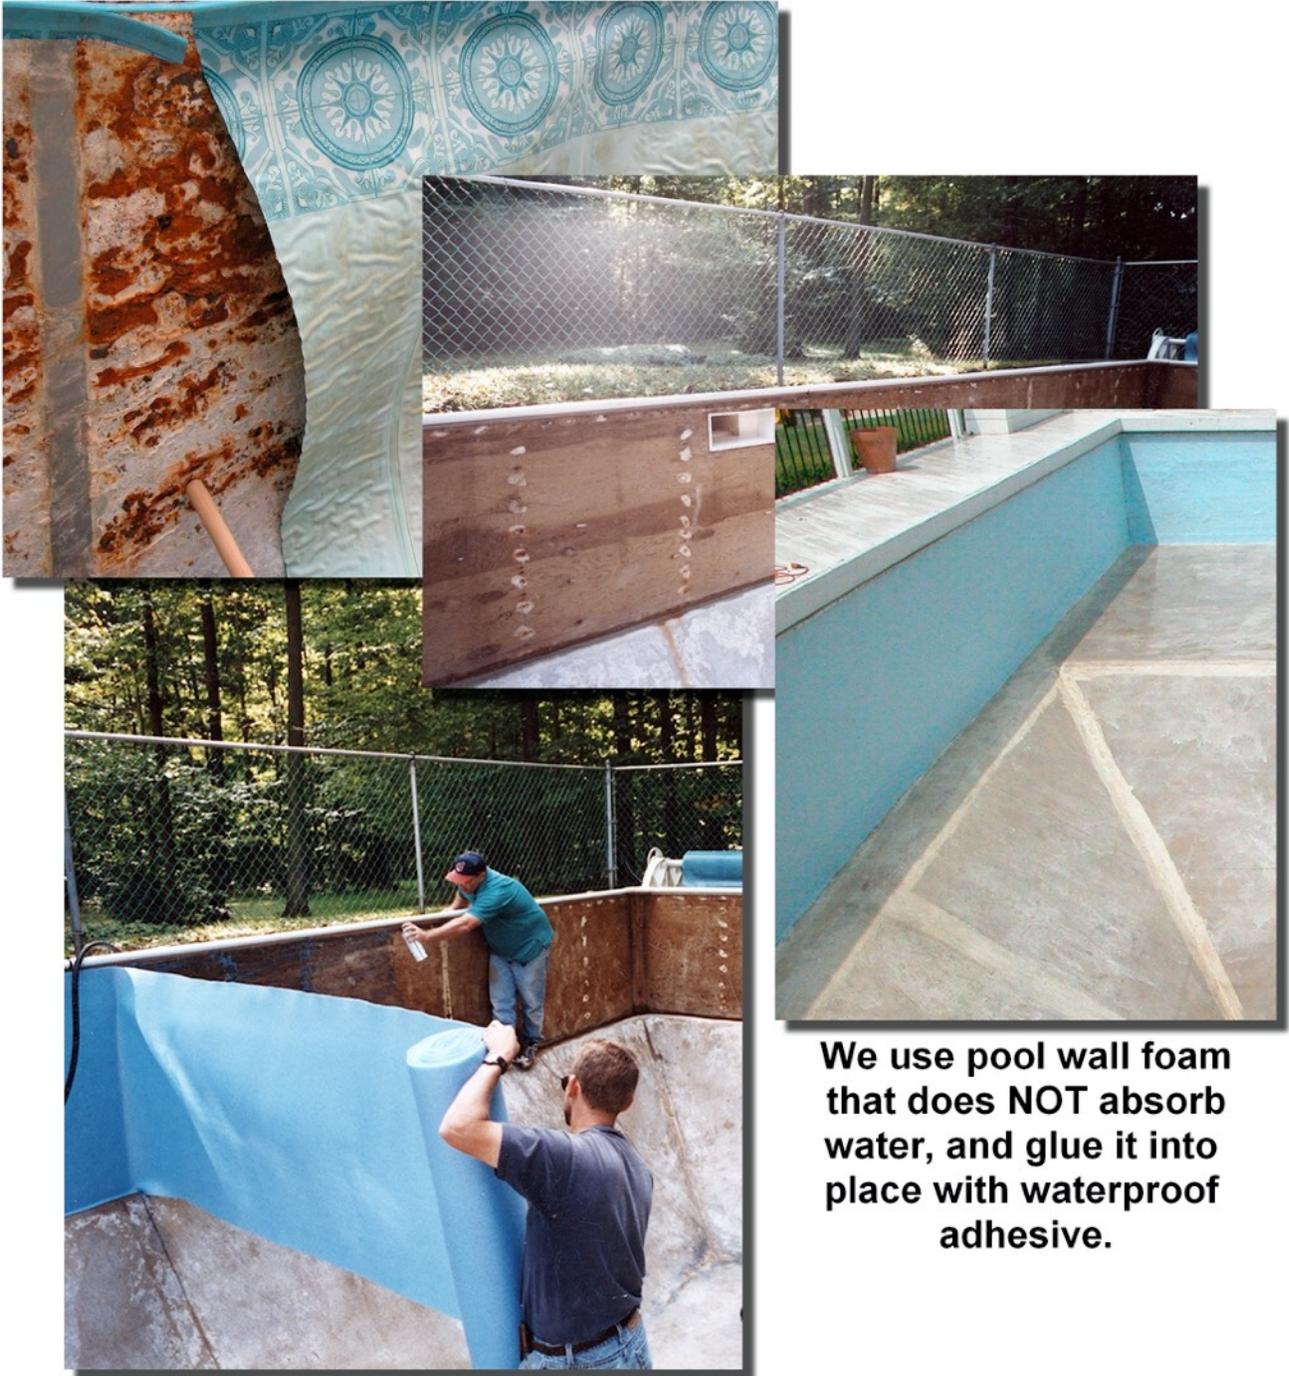
- \* Protects your new liner from rusting steel wall panels or deteriorating wood wall panels.
- \* Creates a smooth even surface for the new liner.
- \* Insulates your pool wall.

**We use pool wall foam that does NOT absorb water, and glue it into place with waterproof adhesive.**

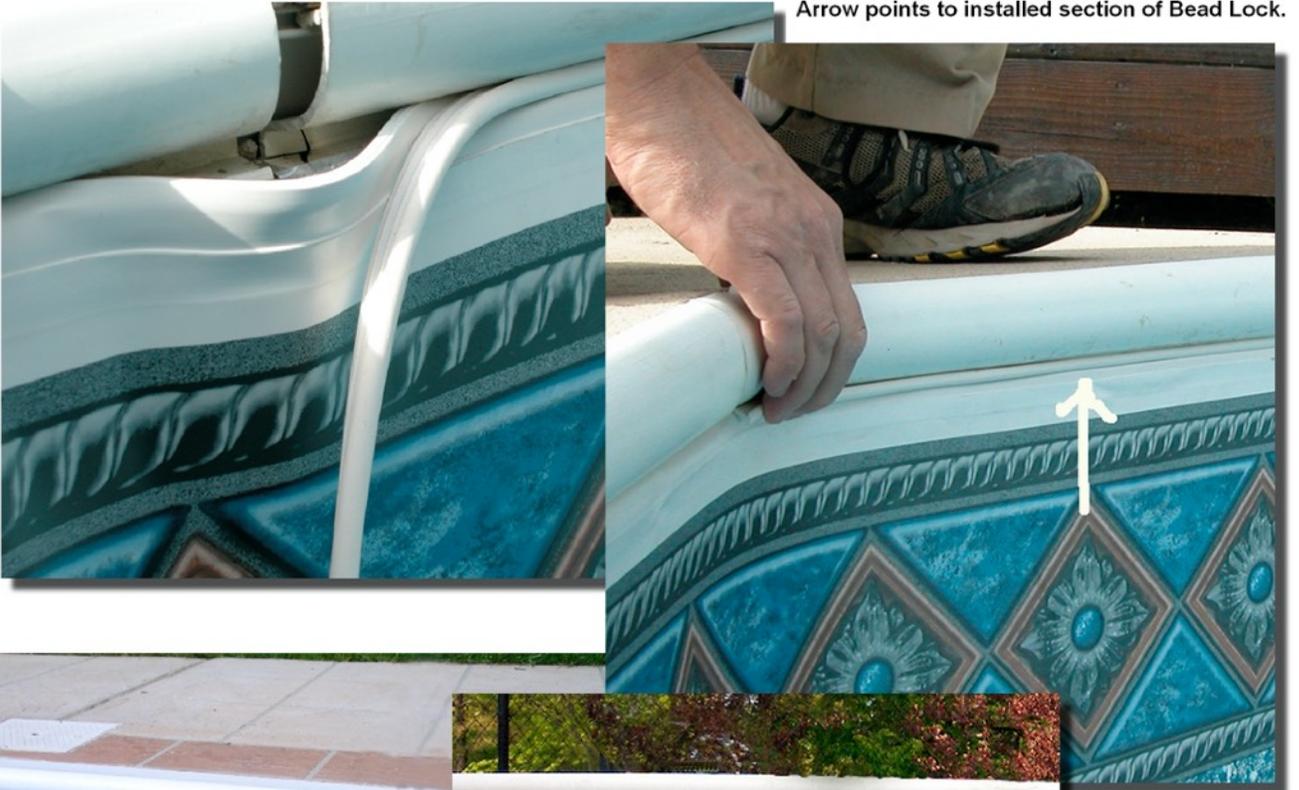
This damaged coping will not securely hold the liner in place. Liner "Bead Lock" is used to hold the liner bead in place.

Arrow points to installed section of Bead Lock.

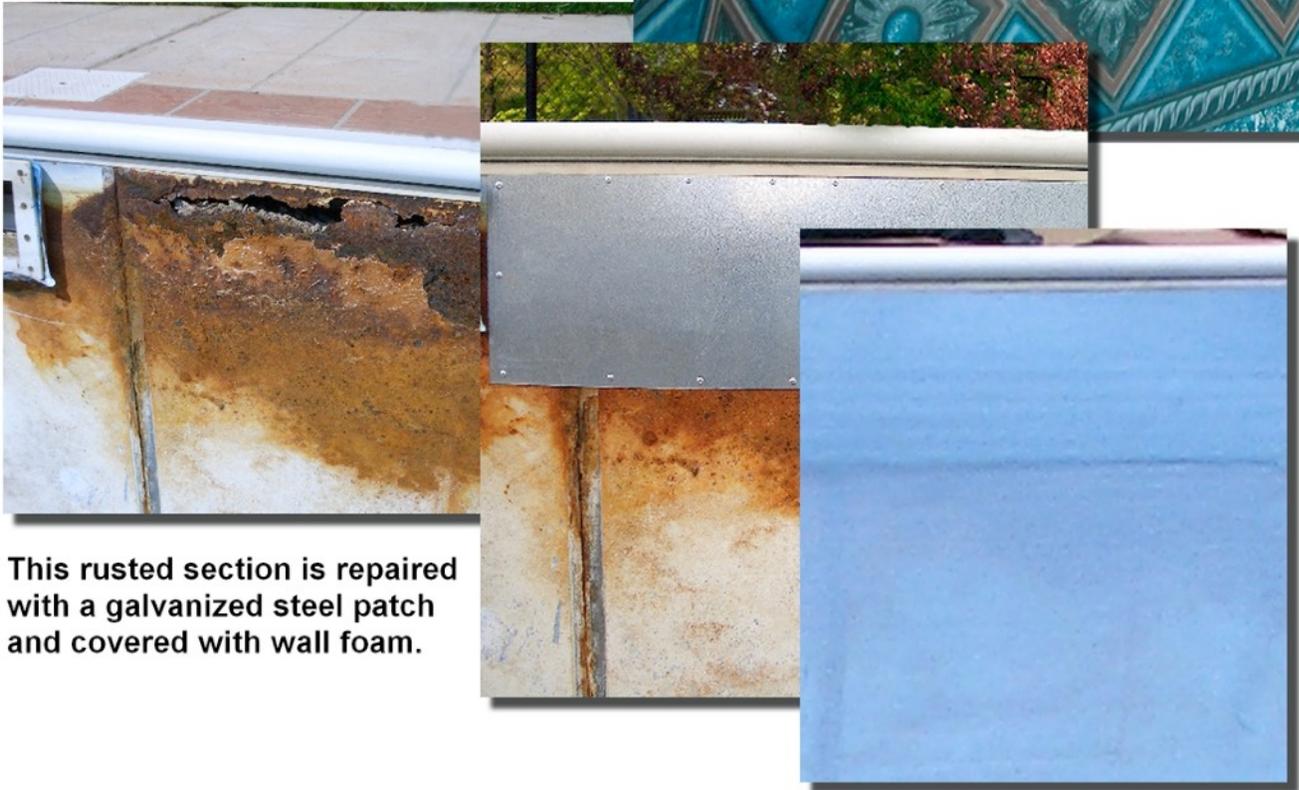
This rusted section is repaired with a galvanized steel patch and covered with wall foam.

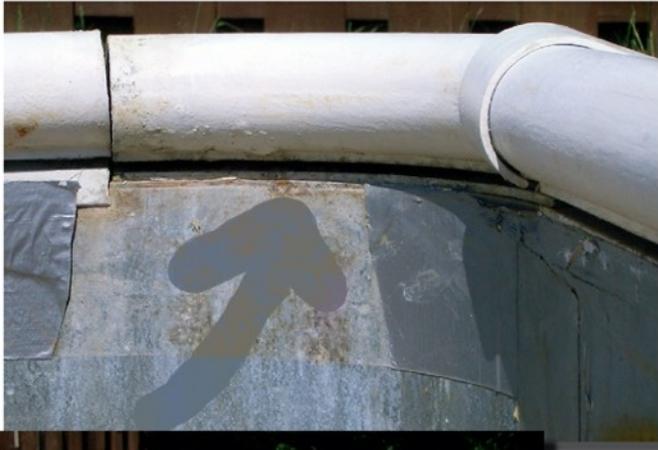
Older pools often have corners that will no longer hold the liner.

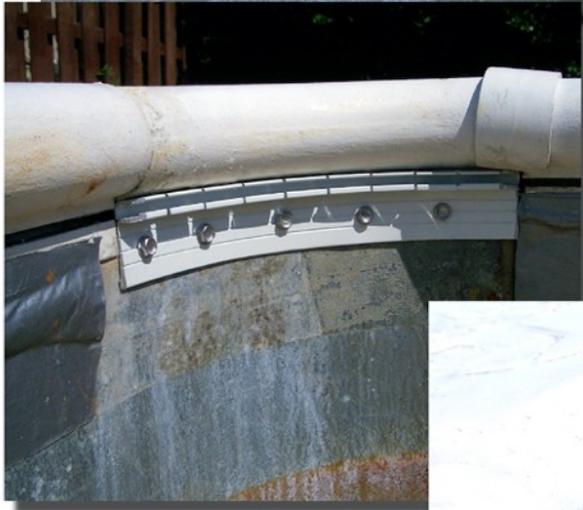
A new piece of aluminum corner tracking is installed with stainless steel fasteners.

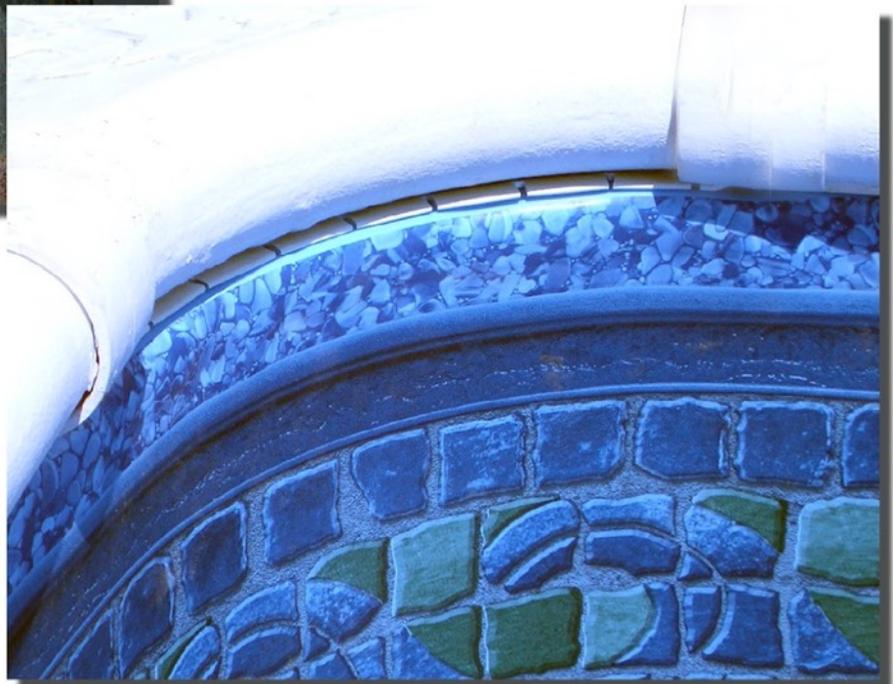
The new track is almost invisible, and the liner is now secure.
